## **LEEDSVILLE SCHOOLHOUSE**

# **PRESERVATION PLAN**

October 2009

16 West Poplar Avenue  
Linwood, New Jersey

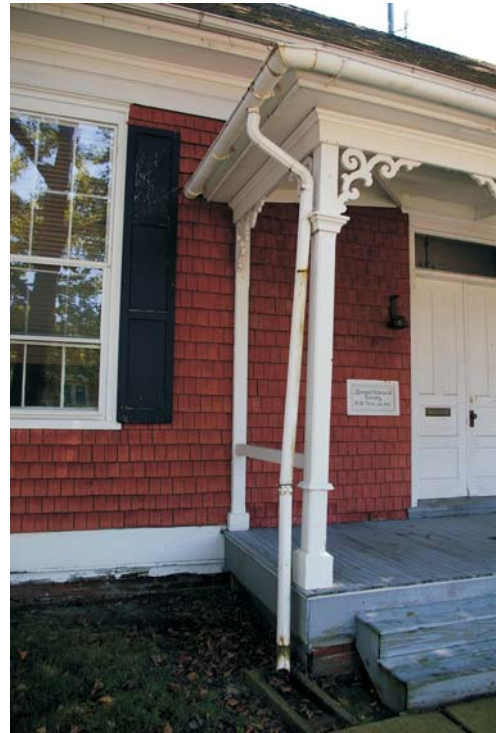
Photograph 3-2

- ◆ While the porch roof is not visible from the ground, there is staining and puddling that suggest water may be leaking through the roof.
- ◆ The porch gutter is also full of debris from the trees. The porch gutter is also attached to the molding of the porch cornice, which has split at the location of some of the attachments. The downspout has corroded at the joints, creating holes through which the water seeps out and down along the porch, and also discharges next to the porch and near the foundations of the building, contributing to damp conditions in the crawlspace. (Photograph 3-2)

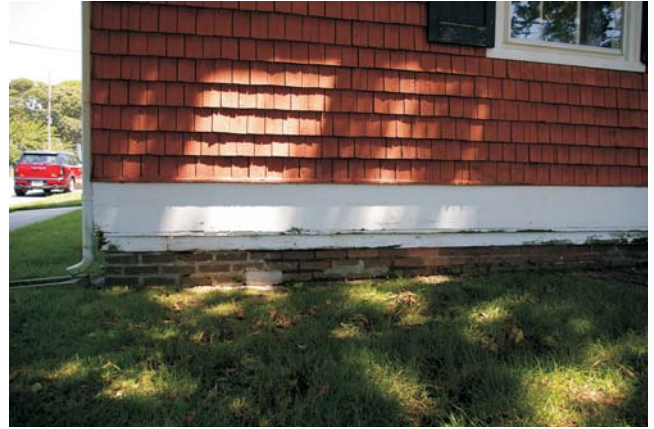
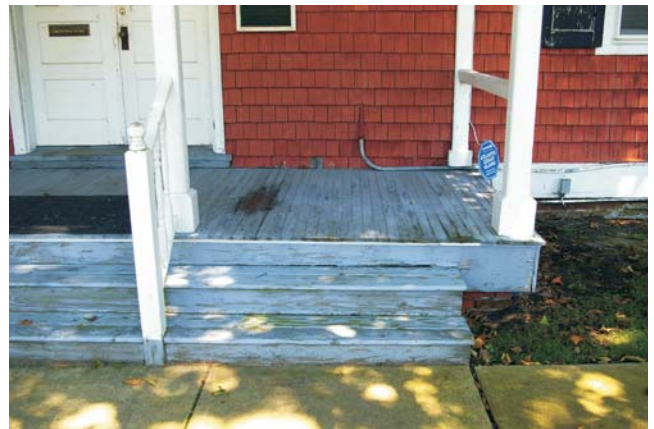
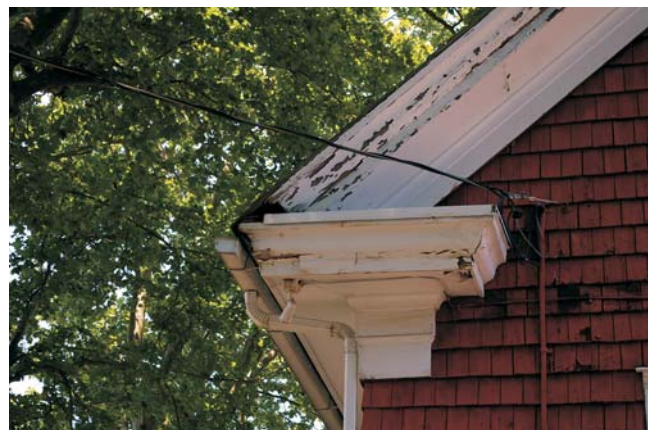
- ◆ The condition of the wood elements on this elevation is typical of the entire exterior. The wood shingles are in fair to poor condition due to age and constant exposure to moisture. The water table is deteriorating due to age, previous inappropriate repairs, constant exposure to moisture, and it is coming loose in some locations. (Photograph 3-9) The porch elements exhibit wood deterioration and one location on the porch floor has a low spot that constantly collects water. (Photograph 3-10) The building cornice is in fair condition on the south elevation, except at the corners, but the north cornice is in generally poor condition, due to the failure of the rainwater conduction systems exposing the cornices to additional water. Small holes at the corners appear to have been made and/or enlarged by small animals. (Photograph 3-11) The shutters also exhibit some deteriorating woodwork. All of the wood elements exhibit peeling paint as well. Paint should be reapplied approximately every five to eight years, and only after proper surface preparation. The lack of recoating, combined with the moisture, has accelerated paint loss and general wood deterioration. The large trees overhanging the building have exacerbated the moisture situation by constantly dripping on the building, clogging the gutters, and creating an overall moist environment, particularly on the south side.

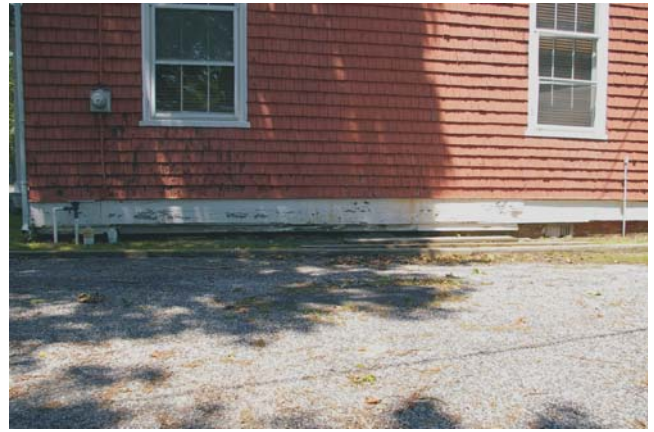
Photograph 3-14

- ◆ The brick foundation also exhibits loss of pointing and inappropriate repairs and repointing, as well as a broken basement vent grate. (Photograph 3-14)
- ◆ The upper storm panel on the south window is broken.

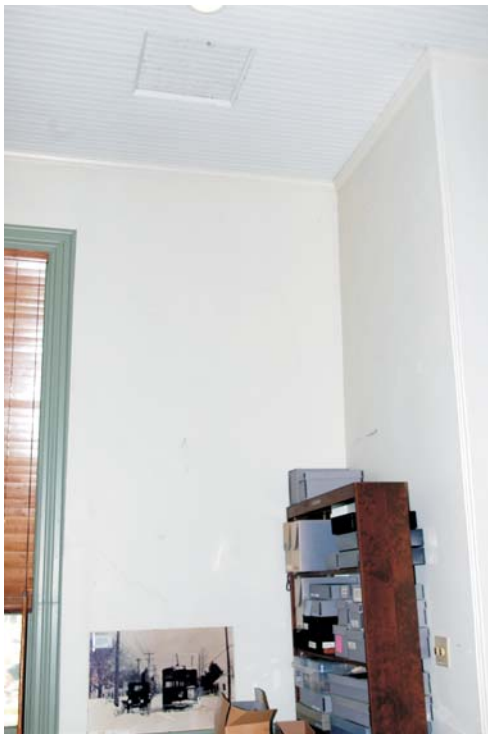
Photograph 3-26

- ◆ The interior of the schoolhouse is in fair to good condition.
- ◆ The floor, although uneven and having been patched over time, is in generally good condition, requiring little in the way of repair or refinishing.
- ◆ The wainscoting has gaps in places, most likely due to the same movement that has caused the unevenness of the floor. The gaps are merely a cosmetic issue, however, and are mostly hidden by museum exhibits.
- ◆ The plaster has hairline cracks, generally extending from the upper corners of the windows up to the ceiling, as well as in other areas, particularly in the southeast corner. The cracks do not appear to be widening over time, although many appear to have been previously repaired and have since reappeared. However, these cracks are not representative of a significant problem. Some peeling paint was also noted on the plaster. (Photograph 3-26)

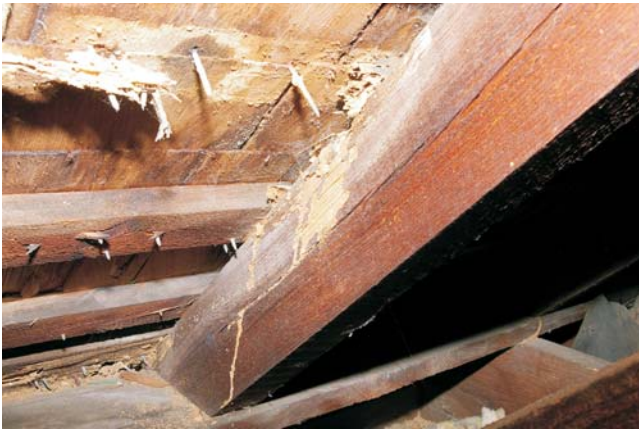
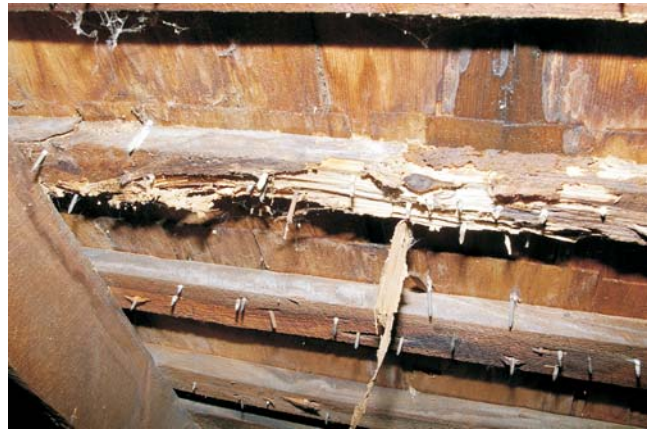
- ◆ There is evidence of termite damage, particularly near the hatch on the south slope of the roof. Entire sections of lath strips have been eaten away. (Photographs 3-40 & 3-41)
- ◆ There is evidence of significant moisture damage at the location of the added chimney on the north slope.

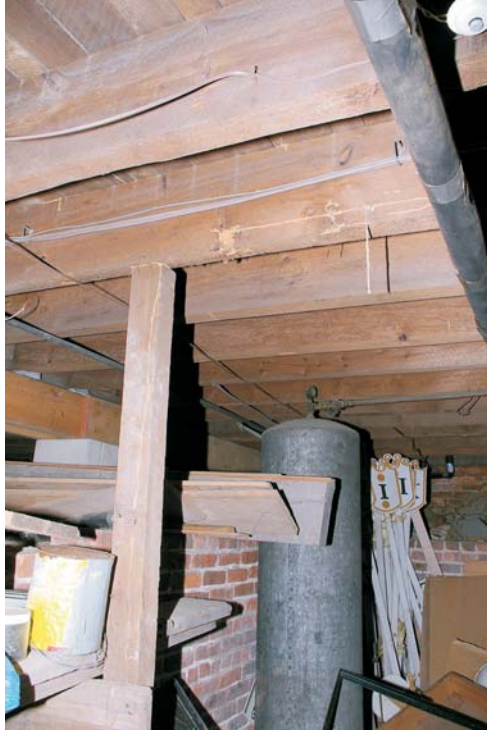
Photograph 3-48

- ◆ There is extensive evidence of termite damage throughout the first floor framing. Although the damage is not continuous from joist to joist, it was noted throughout the basement. (Photograph 3-48)

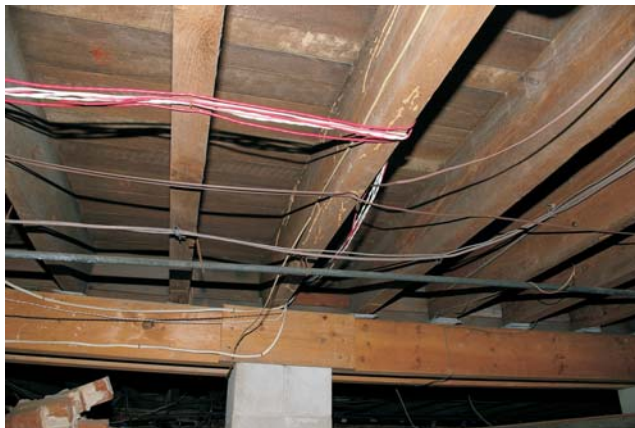
Photograph 3-50

The first floor framing consists of full 3"x9" wood joists, spaced approximately 16 inches on center, spanning from the front and rear exterior masonry walls to a center wood girder. The joists were generally found to be free of large splits or checks, and the joist ends probed along the north wall were found to be sound and free of rot or other damage. Termite damage was observed in several locations throughout the crawlspace. (Photograph 3-50)

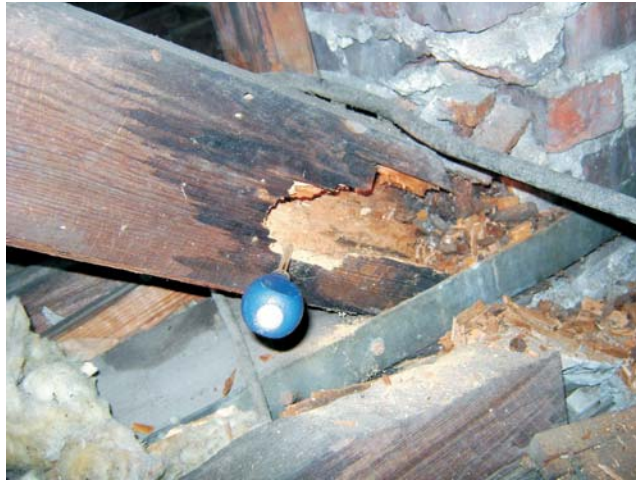
Photograph 3-51

The kingpost trusses are comprised of 6x6 timbers for the top chord and diagonals, and a 6x8 timber for the kingpost. The two intermediate verticals are comprised of 7/8 inch diameter (iron) rods, which extend through the top and bottom chords and are anchored with plate washers and nuts. Threaded rods also clamp the heel joint between the top and bottom chords. The bottom chords consists of an 8x8 timber, with a two inch wide iron strap connecting the kingpost to the bottom chord. The condition of the kingpost trusses was generally good, with the exception of the northern end of the middle truss. The bearing for this truss occurs immediately adjacent to the masonry chimney which extends through the roof. Water leaking through the failed chimney flashing has caused significant deterioration to the top chord of the truss. (Photograph 3-51) A strap was added presumably to reinforce the heel joint, however the deterioration extends beyond limits of the strap, and remedial reinforcing is required.
