**STRUCTURAL ENGINEERING
ASSESSMENT**

**Baker, Ingram & Associates
29 October 2009**

Re: Leedsville Schoolhouse
W. Poplar & Lincoln Avenues
Linwood, NJ
H5672

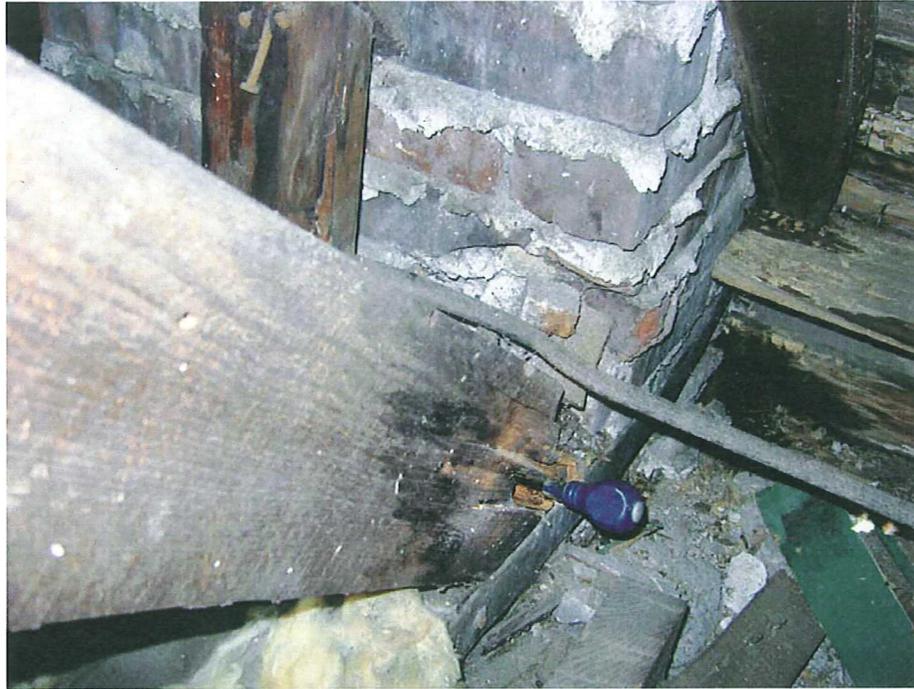
The majority of the roof framing is in generally good condition, with the exception of isolated sections of furring which are deteriorated and in need of replacement. The major concern with the roof is the condition of the north heel joint of the middle truss. The deterioration observed in the top chord of the truss has progressed to a point in which the truss can no longer safely support the roof and ceiling loads. We recommend that the north end of the truss be temporarily shored to provide support for the truss until permanent repairs can be made. The permanent truss repair must address the loss of material in the top chord and be able to develop the connection force between the top and bottom chord. Conceptually the truss repair would replace the deteriorated top chord with a "Dutchman" type of repair, possibly in conjunction with wood or steel side plates to transfer the horizontal component of the axial force in the top chord into the bottom chord. Investigation into the condition of the bottom chord will also be required.

Photograph 1 – North End of Middle Truss @ Chimney

The major work associated with the roof framing is the repair to the heel joint of the middle truss at the north end. The development of the repair detail will require a more thorough investigation and analysis of the truss. Of course the source of the water infiltration must also be addressed.

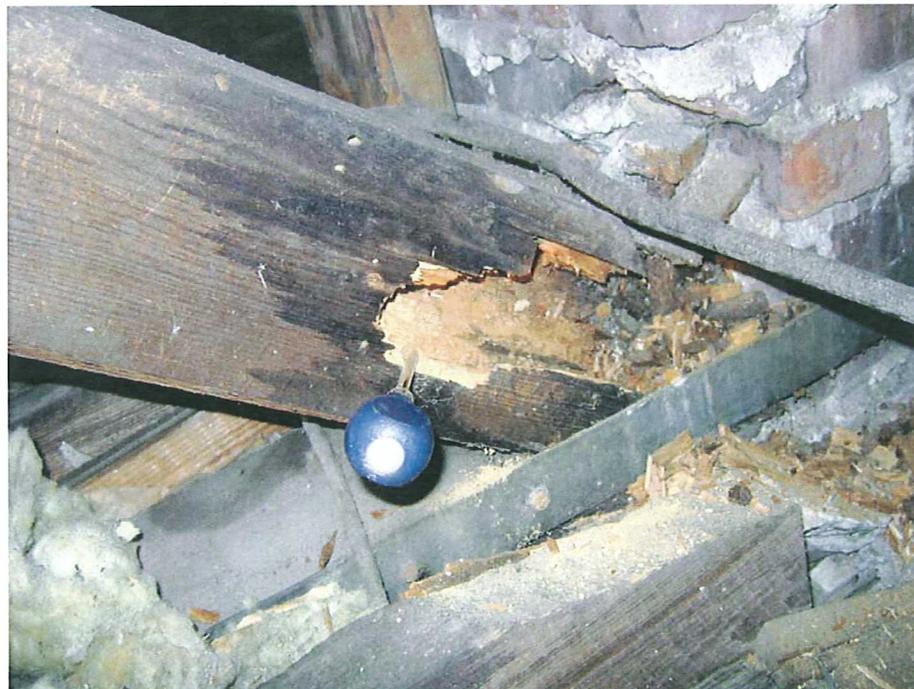
The kingpost trusses are comprised of 6x6 timbers for the top chord and diagonals, and a 6x8 timber for the king post. The two intermediate verticals are comprised of 7/8 inch diameter (iron) rods, which extend through the top and bottom chords and are anchored with plate washers and nuts. Threaded rods also clamp the heel joint between the top and bottom chords. The bottom chord consists of an 8x8 timber, with a two inch wide iron strap connecting the kingpost to the bottom chord. The condition of the kingpost trusses was generally good, with the exception of the northern end of the middle truss. The bearing for this truss occurs immediately adjacent to the masonry chimney which extends through the roof. Water leaking through the failed chimney flashing has caused significant deterioration to the top chord of the truss (see Photograph 1). A strap was added presumably to reinforce the heel joint, however the deterioration extends beyond limits of the strap, and remedial reinforcing is required (see Photograph 2).

Photograph 2 – North End of Middle Truss with Plate Reinforcing
