## **LEEDSVILLE SCHOOLHOUSE**

# **PRESERVATION PLAN**

October 2009

16 West Poplar Avenue  
Linwood, New Jersey

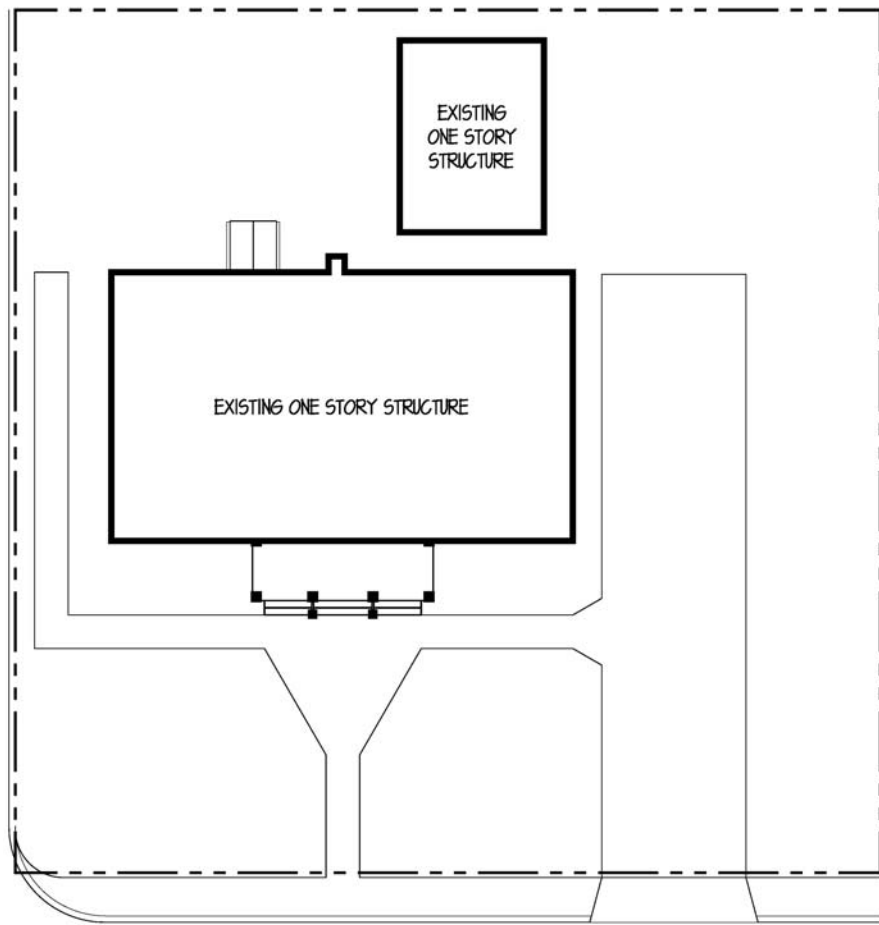
Figure 3-1

- ◆ The trees overhang the roof of the building and drop debris in the gutters, which is contributing to problems with the rainwater conduction system.
- ◆ There are no handicapped-accessible parking facilities.

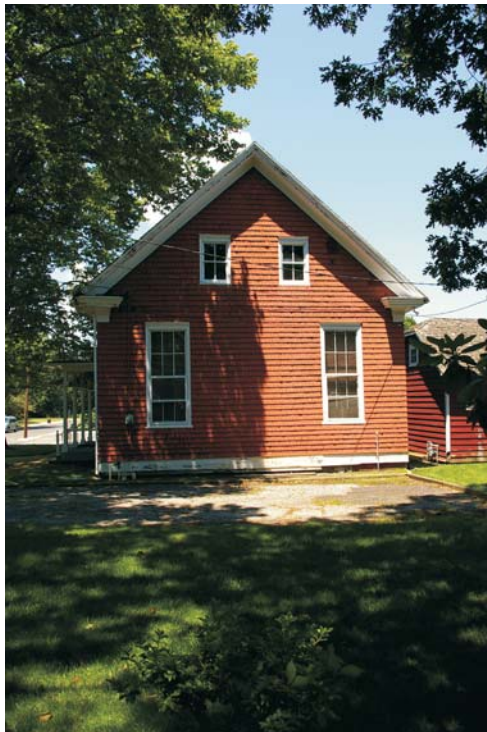
Photograph 3-12

- ◆ The wood conditions are similar to those on the south elevation. The wood elements are deteriorated and exhibit peeling paint. The cornice returns are a vulnerable point for deterioration and holes made by small animals and so are in worse condition than the rest of the cornice.

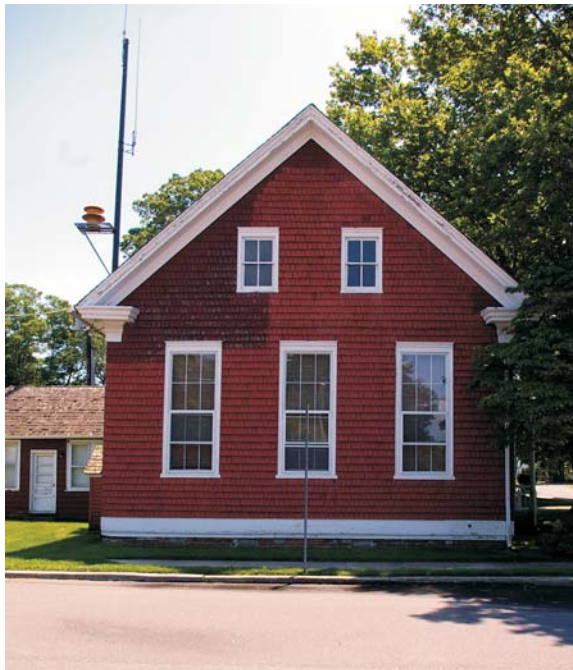
Photograph 3-17

- ◆ This elevation exhibits the same conditions as the other elevation. It was also noted that the drip cap molding on the center first floor window has been damaged.

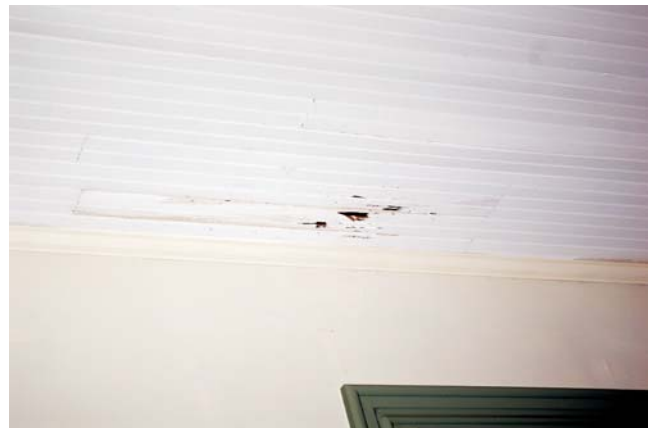
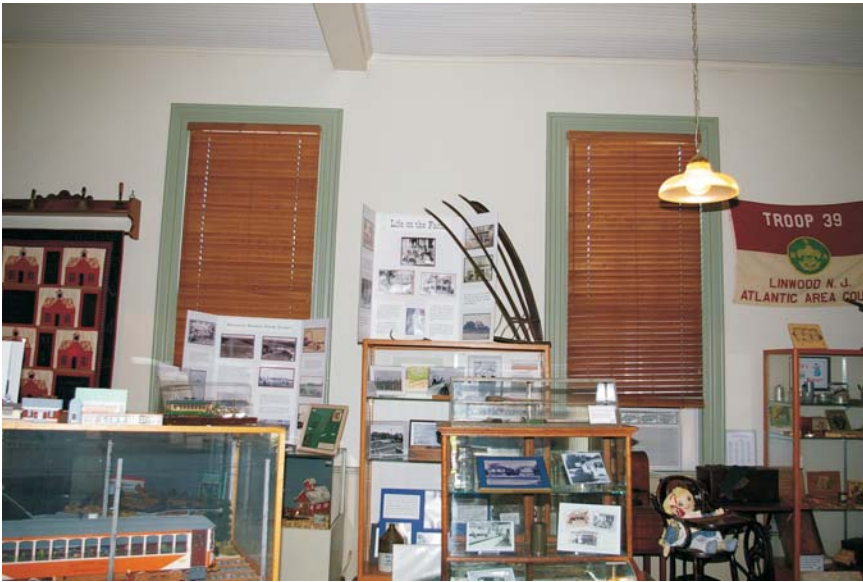
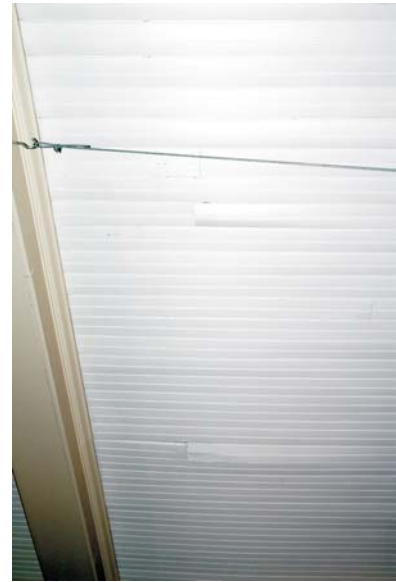
- ◆ One section of the ceiling along the north wall, east of the center beam, has been damaged by moisture from a roof leak. Other areas of the ceiling are uneven and some peeling paint was noted. (Photographs 3-27 through 3-29)
- ◆ The windows appear to be in generally good condition from the interior and some are at least partly operational. Not all of the windows were accessible to test their operability.

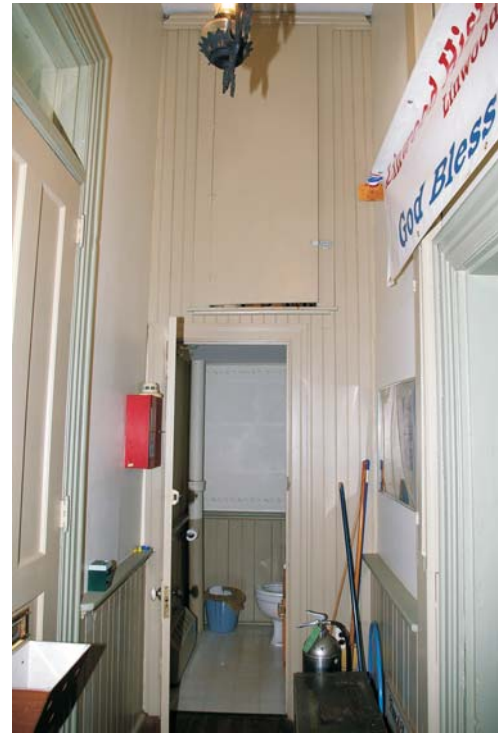
Photograph 3-31

The vestibule, which is 4'-2"x13'-1" and 15' high, occupies roughly the eastern three quarters of the smaller rectangle within the building. (Photographs 3-30 & 3-31) It has the same flooring, wainscoting, shoe molding, chairrail, door trim around the entrance and main room doors, and plaster walls, except that the west wall, which is the restroom partition wall, is made entirely of beaded board. The ceiling in this room is plaster. There is a cornice at the west wall with bullnose/fillet/cyma recta profile from bottom to top.

- ◆ The vestibule exhibits the same problem conditions as the main room: the floor is sloped; there are gaps in the wainscoting; and there are plaster cracks in the walls and ceiling. The front entrance doors, which are not original to the building, are also not properly aligned; the two leaves rub against each other, making it difficult to open and close the doors.

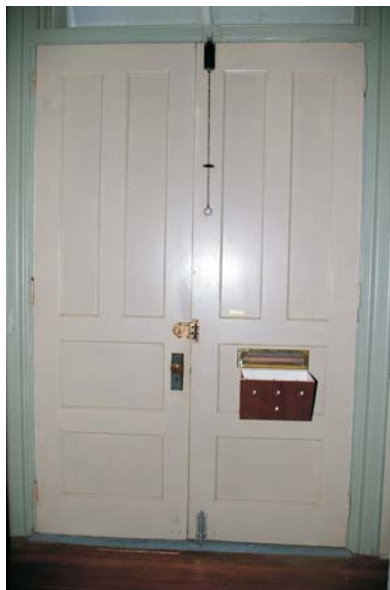
Photograph 3-32

The main entrance doors, located in the south wall, are four-panel, double-leaf doors. (Photograph 3-32) The panels, two vertical above two horizontal, are recessed and have an applied ovolo/fillet molding. The door knob is a plain round metal knob with a band around it and a plain chamfered backplate. There are three five-knuckle, ball-tipped hinges on each door, as well as a surface deadbolt, a mail slot in the west door with a basket to catch the mail, a top bolt with a pull chain release, and a bottom bolt. A two-panel door in the west wall leads to the restroom. The panels are recessed and have a cavetto/ovolo applied molding. The trim around the door has a cyma reversa/fascia/quirked ovolo/fillet profile from inside to outside. The knob is porcelain and has a plain, chamfered backplate. In the west wall, above the bathroom door, is a flush door with plain trim that provides access to a storage space. The door opening in the north wall with typical trim leads into the main room.

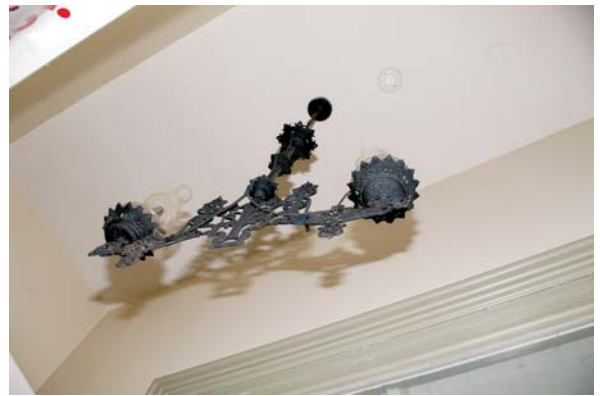
Photograph 3-33

small access door in it, an electrical box and an obsolete fire alarm box, and a two-light cast iron chandelier. (Photograph 3-33) The chase running up the north wall once housed the rope for the school bell located in the former belfry.

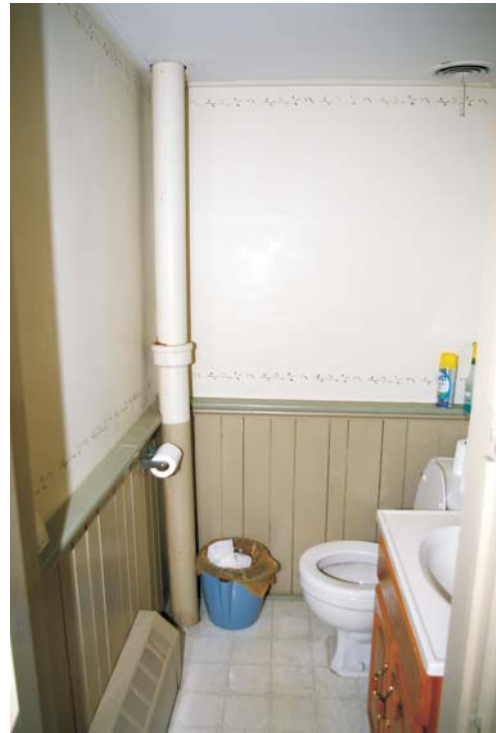
Photograph 3-34

The restroom is a small room located to the west of the vestibule. (Photograph 3-34) The small space, approximately 4x5' in size, has a vinyl floor, plaster walls above the typical wainscoting, and a plywood ceiling. The door, set in the east wall, has stock trim with a half-bead/fascia/cyma recta/fillet molding. A small cornice has an ovolo/splay profile. The toilet is set in the northwest corner of the room, while the sink is in the northeast corner with a mirror and three-light fixture over it. The soil stack is in the southwest corner of the room, an obsolete exhaust fan is located in the northwest corner of the ceiling, and a radiator is located against the south wall. The wainscoting has been modified/removed behind the toilet and sink.

The restroom is in fair to poor condition.

- ◆ There are gaps in the wainscoting and cracks in the plaster.
- ◆ The fixtures are old and there is no hot water.
- ◆ The exhaust fan does not work.
- ◆ The room is not, and cannot be, handicapped accessible.

The existing toilet room does not meet ADA requirements and the plumbing fixtures should be considered for replacement.

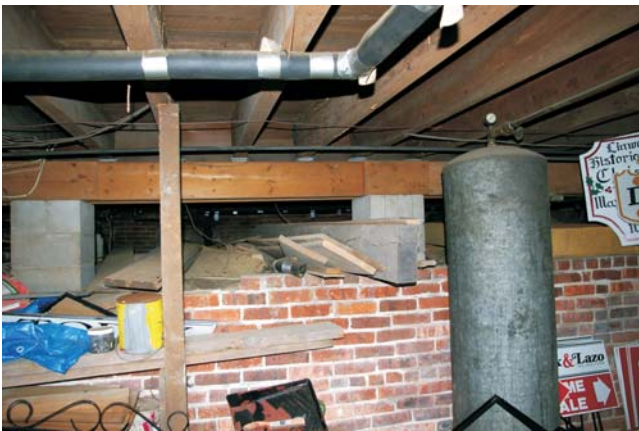
Photograph 3-42

The basement is partially excavated. (Photograph 3-42) The entire southern half of the basement is a crawlspace, as is the northeastern quarter and a small area in the northwestern corner. (Photograph 3-43) The center and most of the northwestern portion of the basement have been excavated to make room for a boiler and an oil tank with an overflow tank. The oil tank is set on an area of basement floor that is about two feet higher than the boiler area floor. The floor has been covered with concrete at these two levels, but not over the crawlspace area. The boiler is located to the east of the basement entrance, which is set between the western two windows on the north elevation. (Photograph 3-44) The oil tank, located to the west of the entrance, has been abandoned, but remains in place, along with the overflow tank. The walls of the excavated area are brick. Some areas, particularly along the south wall of the excavated area, show what appears to be original pointing, while other areas have been repointed with various types of mortar.

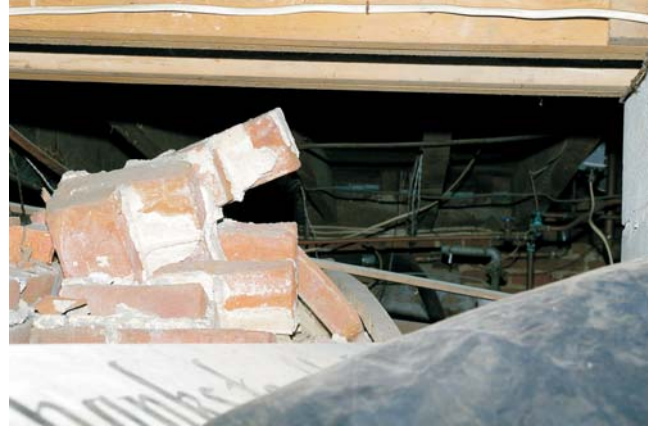
Photograph 3-45

A replacement summer beam with replacement concrete piers runs east-west, while the original, circular-sawn joists run north-south. Debris from the previous brick piers and sections of wood that may be from the original summer beam remain in the crawlspace. (Photographs 3-45 & 3-46) Above the joists, at the location of a previous circular grate that may have served the initial central heating system, the edges of two layers of flooring are exposed. The lower layer, which runs east-west, is approximately one inch thick and is random width, while the layer above is about  $\frac{3}{4}$ " thick. Both layers are beneath the current finish flooring. The base of one of the original interior chimneys is visible on the west wall, as is a modern vent grate.

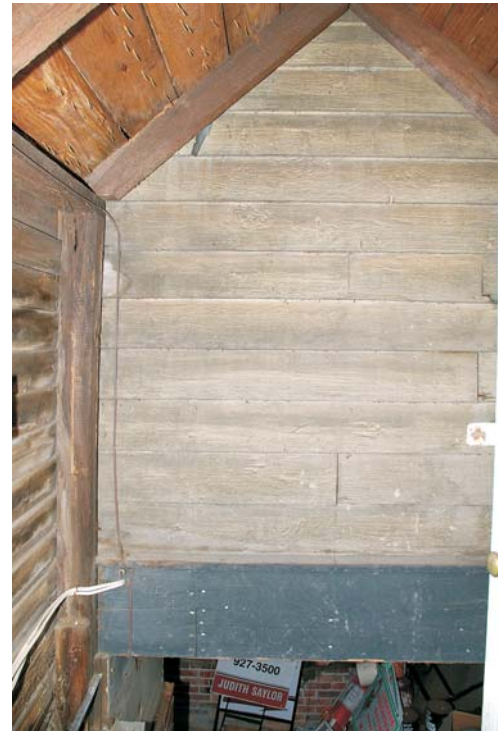
Photograph 3-47

The entrance to the basement consists of concrete steps outside the footprint of the building that are covered by a small frame structure. The structure is unfinished on the interior. Original clapboard siding is exposed on the north wall of the building, where it is covered by this structure. (Photograph 3-47) This clapboard appears to be in good condition.
