**STRUCTURAL ENGINEERING
ASSESSMENT**

**Baker, Ingram & Associates
29 October 2009**

Re: Leedsville Schoolhouse
W. Poplar & Lincoln Avenues
Linwood, NJ
H5672

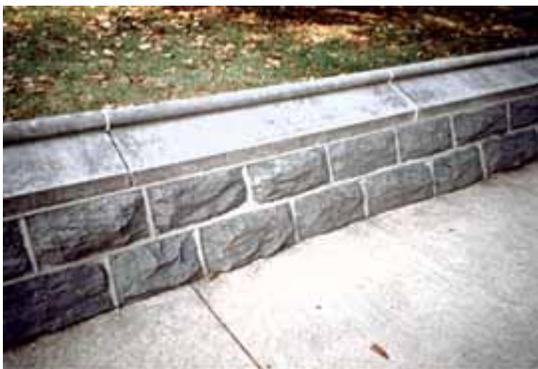
Caulking was inappropriately used here in place of mortar on the top of the wall. As a result, it has not been durable. Photo: NPS files.

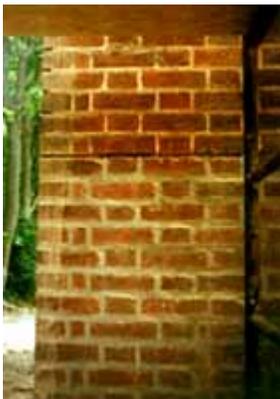
A mechanical grinder improperly used to cut out the horizontal joint and incompatible repointing have seriously damaged the 19th century brick. Photo: NPS files.

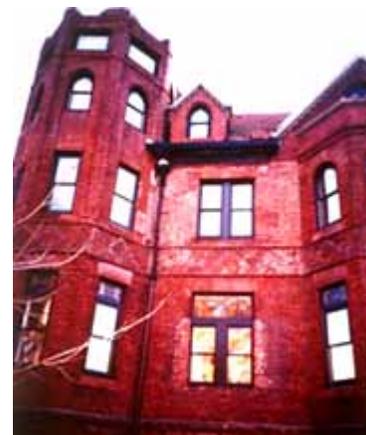
Unskilled repointing has negatively impacted the character of this late-19th century building. Photo: NPS files.

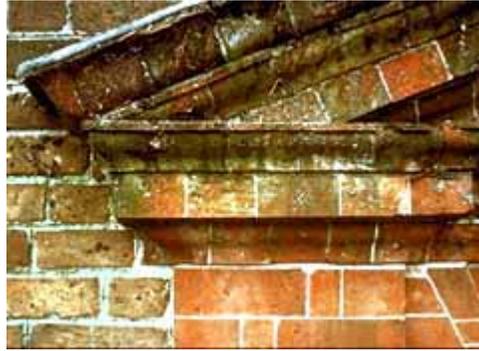
This 18th century pediment and surrounding wall exhibit distinctively different mortar joints. Photo: NPS files.

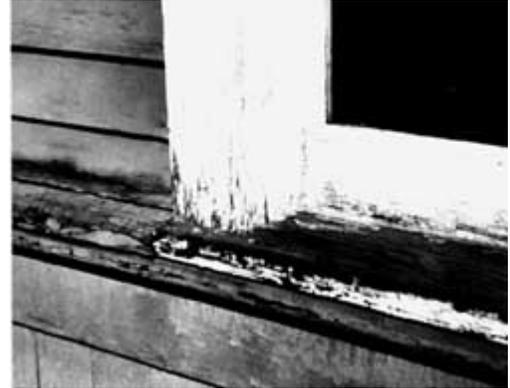
Deterioration of poorly maintained windows usually begins on horizontal surfaces and at joints, where water can collect and saturate the wood. Photo: NPS files.

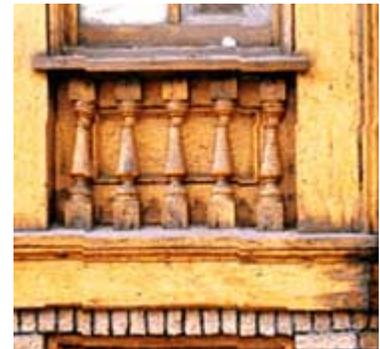
When the protective and decorative paint finish was removed and an inappropriate clear finish applied, the exterior character of the building was altered. Photo: NPS files.

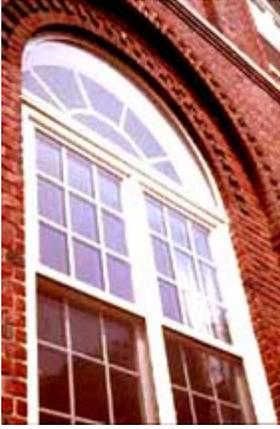
When the paint on the wood windows became too thick, it was removed and the window repainted. Photo: NPS files.

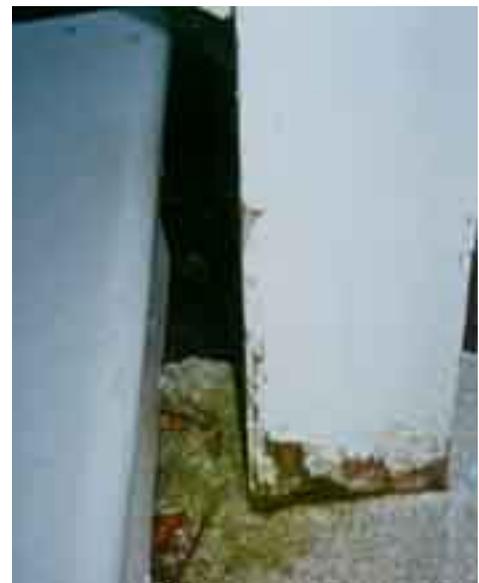
The problem evidenced here by mossy growth and deteriorated wood must be resolved and the wood allowed to dry out before the wood is repainted. Photo: NPS files.

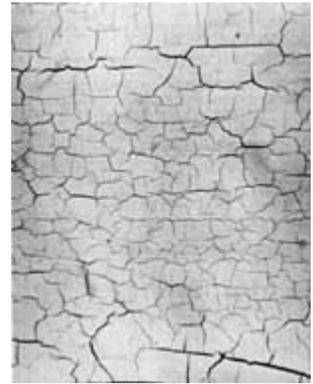
Crazing--or surface cracking--is an exterior surface condition which can be successfully treated by sanding and painting. Photo: Courtesy, National Decorating Products Association.

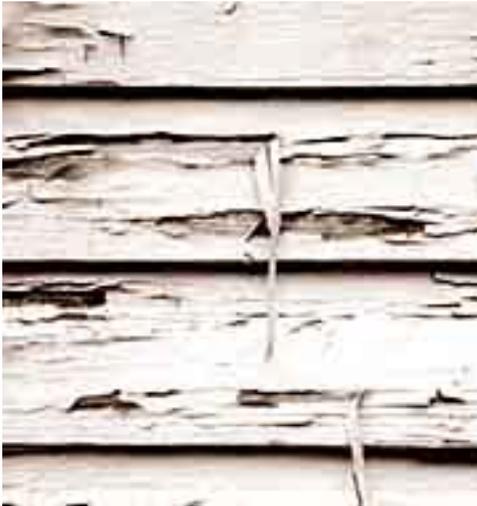
Extensively deteriorated paint needs to be removed to bare wood, then primed and re-painted. Photo: NPS files.

Peeling to bare wood is most often caused by excess interior or exterior moisture that collects behind the paint film, thus impairing adhesion. Generally beginning as blisters, cracking and peeling occur as moisture causes the wood to swell, breaking the adhesion of the bottom layer.

There is no sense in repainting before dealing with the moisture problems because new paint will simply fail. Therefore, the first step in treating peeling is to locate and remove the source or sources of the moisture, not only because moisture will jeopardize the protective coating of paint but because, if left unattended, it can ultimately cause permanent damage to the wood. Excess interior moisture should be removed from the building through installation of exhaust fans and vents. Exterior moisture should be eliminated by correcting the following conditions prior to repainting: faulty flashing; leaking gutters;

defective roof shingles; cracks and holes in siding and trim; deteriorated caulking in joints and seams; and shrubbery growing too close to painted wood. After the moisture problems have been solved, the wood must be permitted to dry out thoroughly. The damaged paint can then be scraped off with a putty knife, hand or mechanically sanded, primed, and repainted.

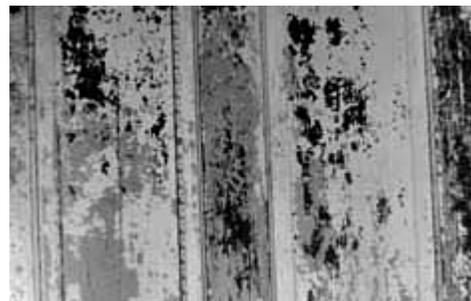
A dark layer can be seen beneath the flaking paint on these raised field panels. Depending on the project work goal and the period of the building's history being interpreted, any one of the paint layers could be duplicated in repainting. Photo: NPS files.
